How additional data can improve your perspective

by Marc Tompkins
Regional Sales and Service Manager
Bently Nevada Corporation
Wexford, Pennsylvania

Homer City Station's Unit #2 is a 600 MW Westinghouse tandem unit with 11 bearings. The unit's vibration monitoring system uses both proximity and casing-mounted transducers. More importantly, and key to Pennsylvania

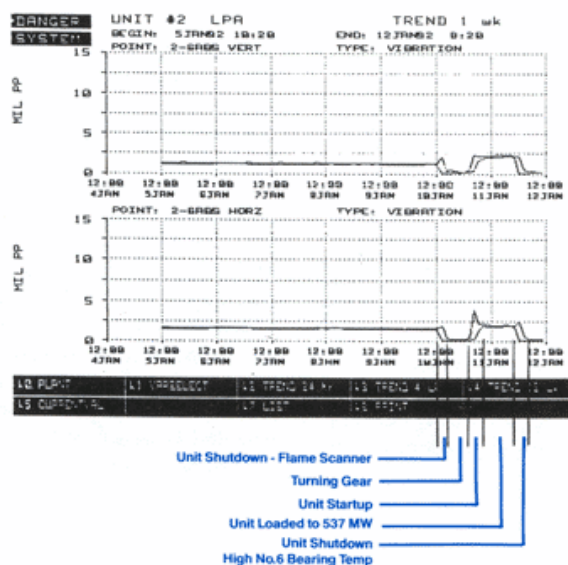
Figure 1A & 1B

He reviewed the No. 6 bearing's temperature excursions as he wanted to be confident it was the only bearing with a problem. Roll-up and coastdown vibration data indicated levels no higher than 3 to 3.5 mils, which were acceptable levels. Figures 1A and 1B illustrate a trend of the horizontal and vertical probe vibration levels at the No. 6 bearing. Krejdovsky remarked, "I knew we had a problem, and I knew bearing No. 6 was the likely candidate. I didn't know how severe the problem was, and from my viewpoint, it was possible a bad thermocouple was leading us astray."

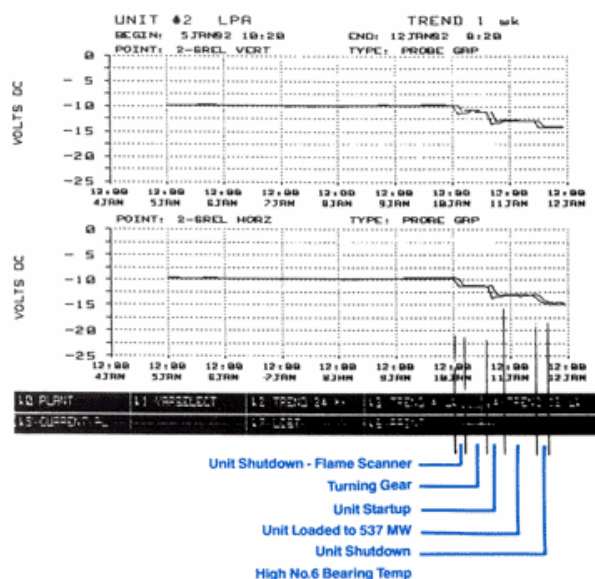
Figure 2A & 2B

Carl examined Trend gap voltage data from the No. 6 bearing horizontal and vertical probes, as well as that of probes of adjacent bearings, from steady state operation prior to the flame scanner system failure, through the shutdown, and the subsequent startup and second shutdown. The probe gap voltage data supplies information about the static position of the journal inside the bearing clearance. During the shutdowns and startups, the gap voltage of both probes on bearing No. 6 became more negative (Figures 2A & 2B). The No. 6 bearing was progressively wiping during each roll-up and coastdown, causing the rotor journal to drop step-by-step in the bearing. A review of the gap voltage values just after the previous outage (Figures 3A and 3B) confirmed the rotor had fallen below the -11.0 to -11.5 Vdc normal turning gear values. Krejdovsky concluded, "The gap voltage information defined the severity of the problem ... I now knew it was a very real and severe problem."

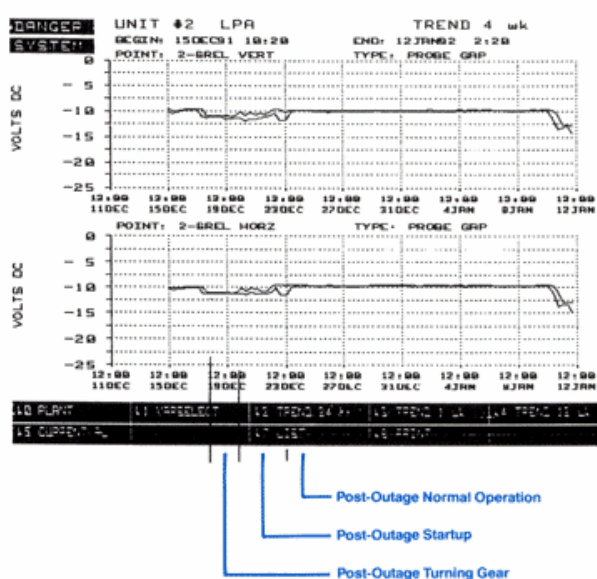
Figure 3A & 3B

Review of gap voltage data from the adjacent bearings revealed little or no changes from nominal. Krejdovsky added, "No. 6 bearing was the problem,
